ANNUAL REPORT FOR 2010

**UT to Irish Buffalo Creek Mitigation Site
Cabarrus County
TIP No. R-2533B (Site 12)**

Prepared By:
Natural Environment Unit & Roadside Environmental Unit
North Carolina Department of Transportation
October 2010

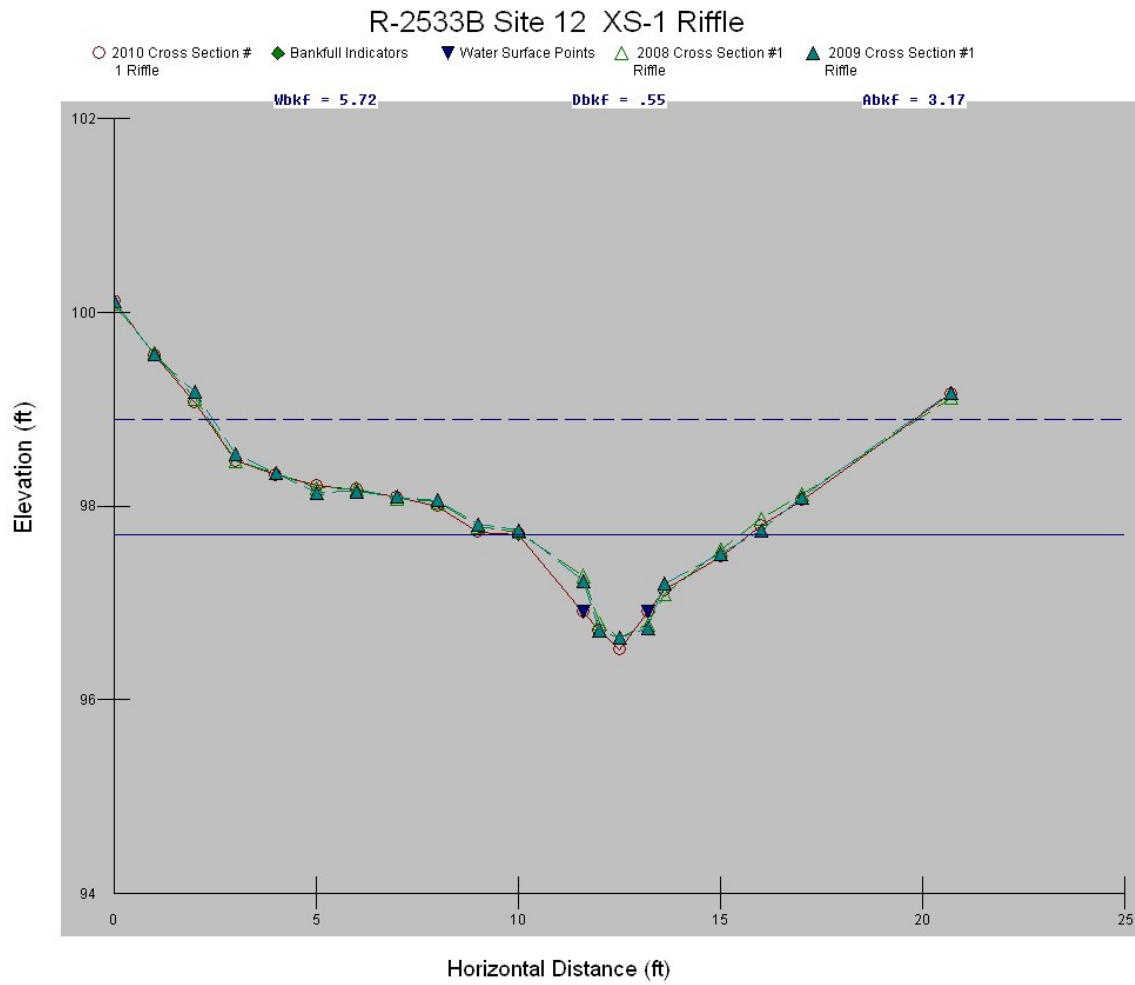
Site #12: Cross-Section #1 (Riffle) Abbreviated Morphological Summary

Based on comparisons of all three years of monitoring data, all of the cross sections appear stable with little or no active bank erosion. Graphs of the cross sections are presented in Appendix A. Future survey data will vary depending on actual location of rod placement and alignment; however, this information should remain similar in appearance. A bankfull event had recently occurred onsite. Pebble counts were not required per the permit conditions and therefore were not completed.

2008	2009	2010	2011	2012
Bankfull Cross Sectional Area (ft²)	2.8	3	3.17		
Maximum Bankfull Depth (ft)	1.1	1.1	1.19		
Width of the Floodprone Area (ft)	17.1	17.1	17.54		
Bankfull Mean Depth (ft)	0.5	0.5	0.55		
Width/Depth Ratio	11.1	12	10.4		
Entrenchment Ratio	3.1	2.9	3.07		
Bankfull Width (ft)	5.6	6	5.72

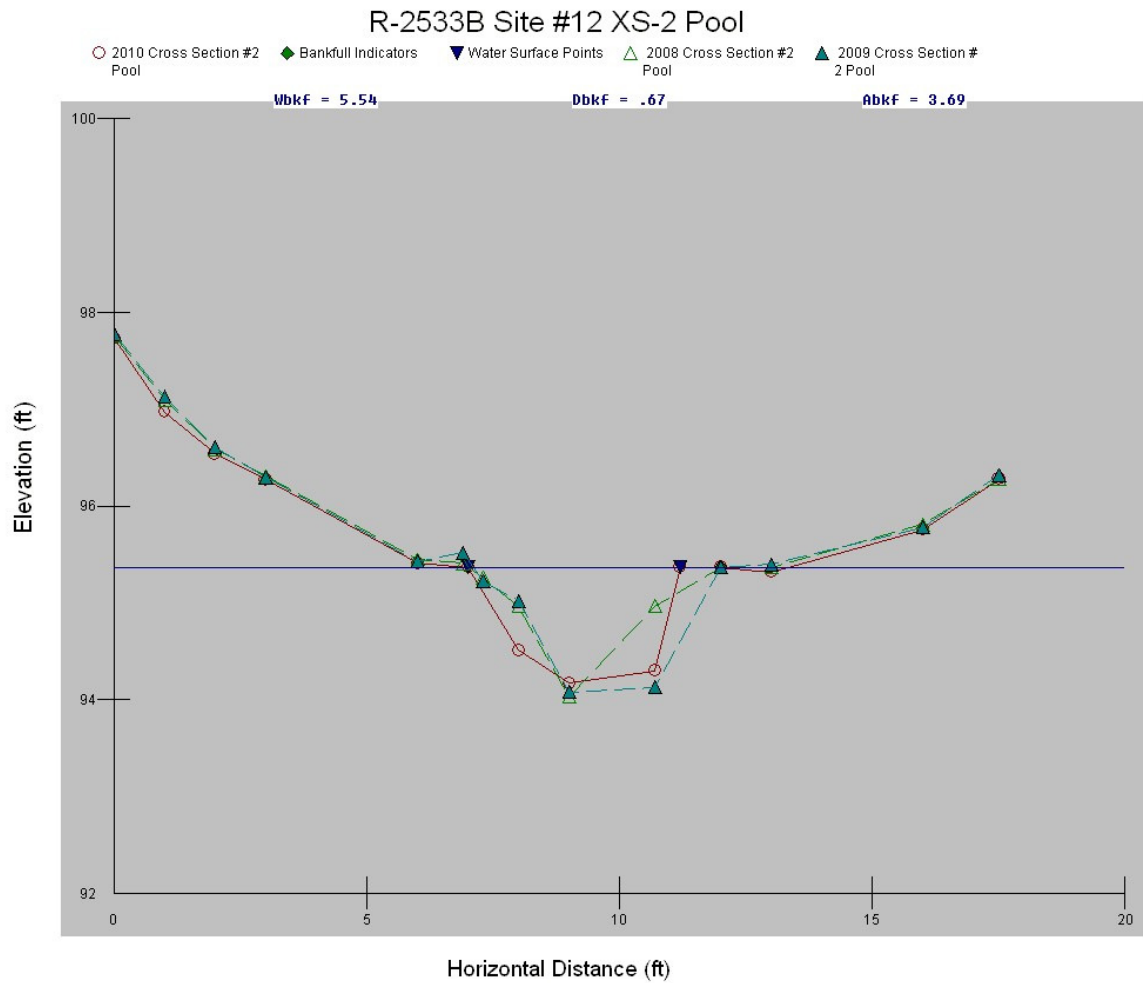
Site #12: Cross-Section #2 (Pool) Abbreviated Morphological Summary*

2008	2009	2010	2011	2012
Bankfull Cross Sectional Area (ft²)	2.8	3.9	3.69		
Maximum Bankfull Depth (ft)	1.3	1.3	1.2		
Bankfull Mean Depth (ft)	0.7	0.8	0.67		
Bankfull Width (ft)	4.9	4.9	5.54
